# Exhibit A

Allen Consulting Services  
Building Consulting and Appraisal Services

5/8/2025

Co. Claim Number : 300-438846-2023  
Insured : Gina Gilmore  
Policy Number : 44-883661-00  
Policy Term : 1/28/2023 to 1/28/2024  
Date of Loss : 5/10/2023  
Location of Loss : 9285 Melborne Ct  
Parker, CO 80134

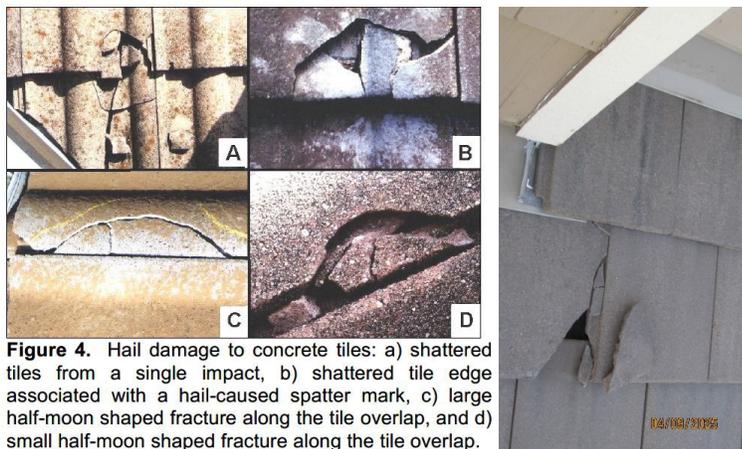
**Figure 4.** Hail damage to concrete tiles: a) shattered tiles from a single impact, b) shattered tile edge associated with a hail-caused spatter mark, c) large half-moon shaped fracture along the tile overlap, and d) small half-moon shaped fracture along the tile overlap.

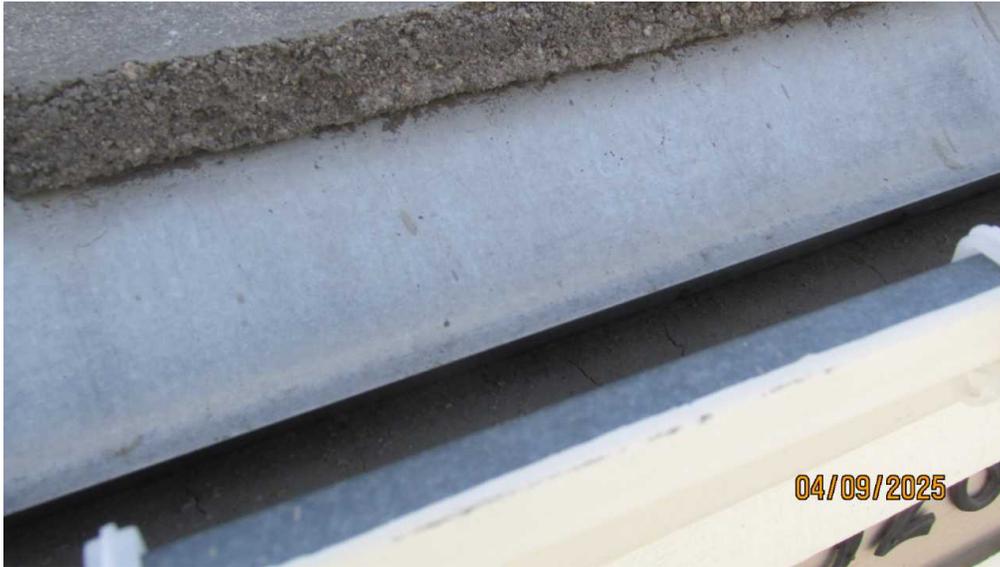
### 3-Gilmore

drip edge installed on tile roof

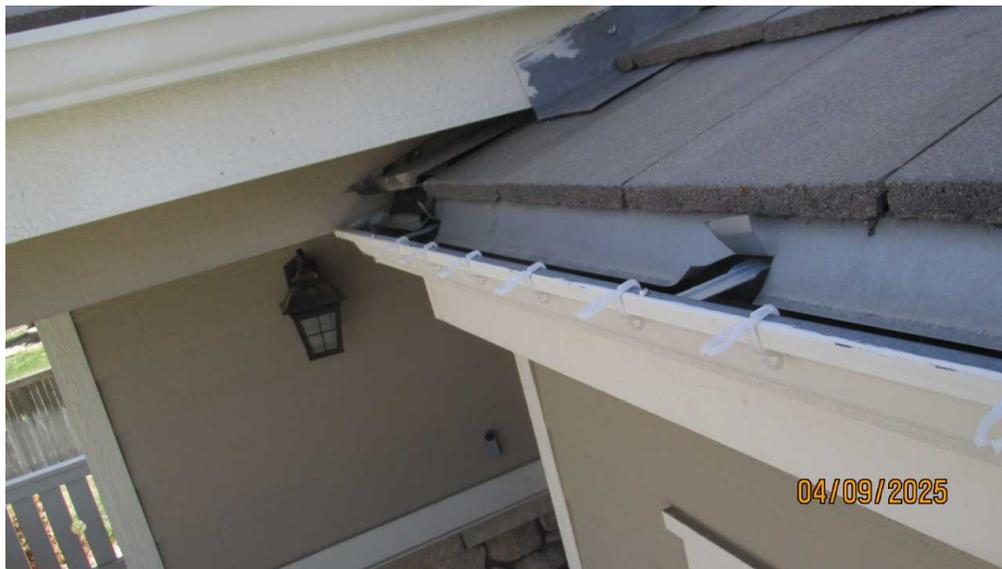
## 5-Gilmore

gutters NOT installed on top of drip edge

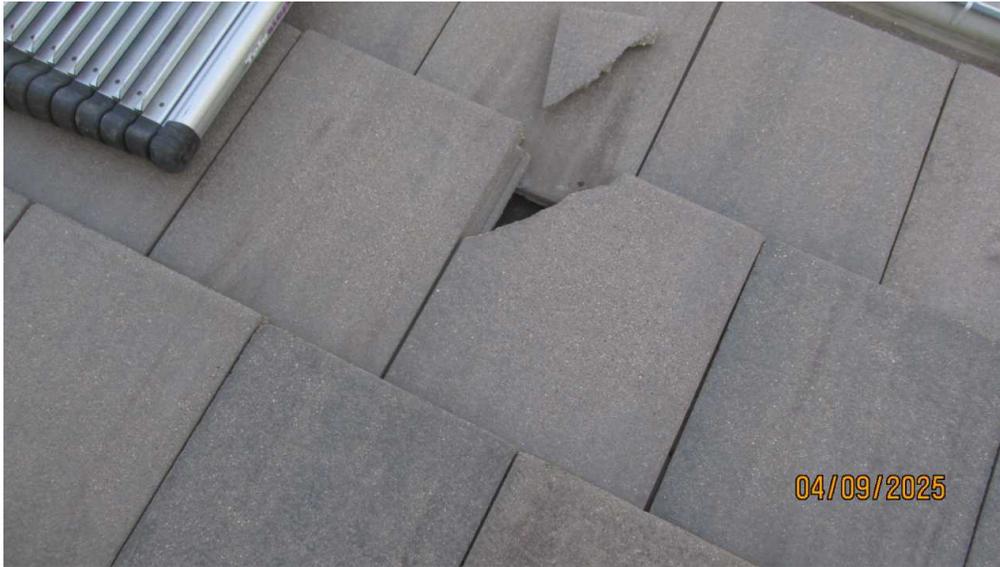
## 7-Gilmore

cracked/damaged tile

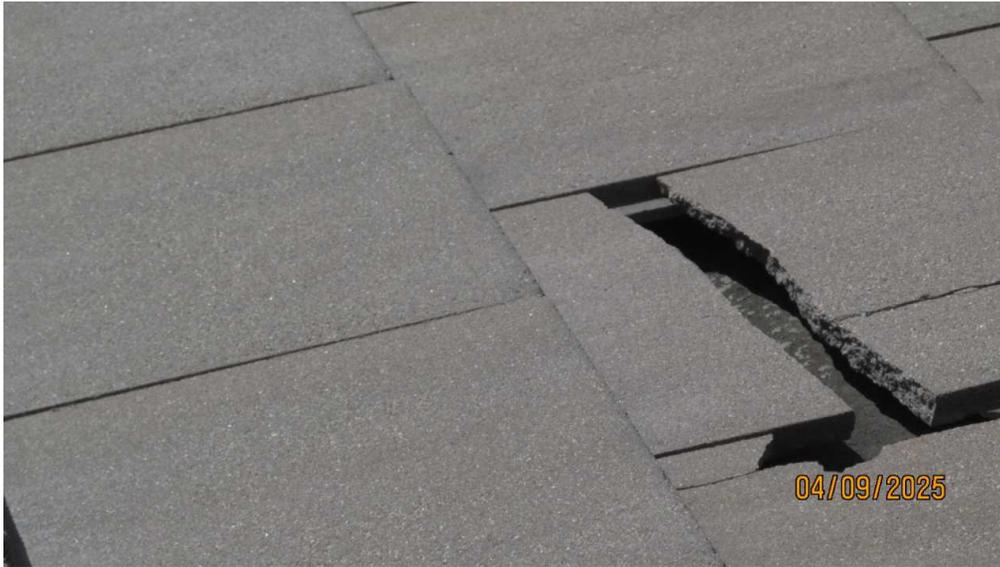
**13-Gilmore**

cracked/damaged tile

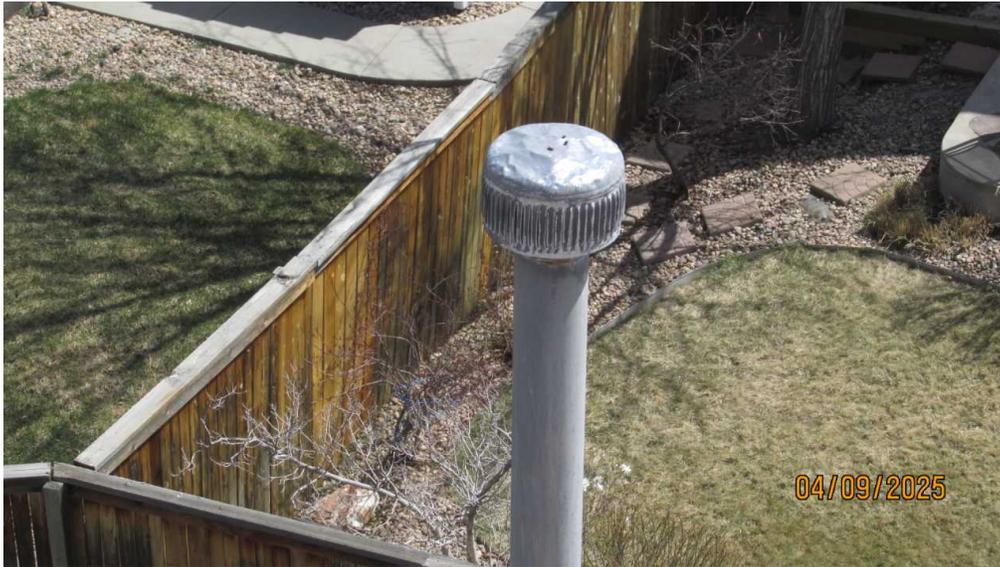
## 25-Gilmore

hail dents in vent cap

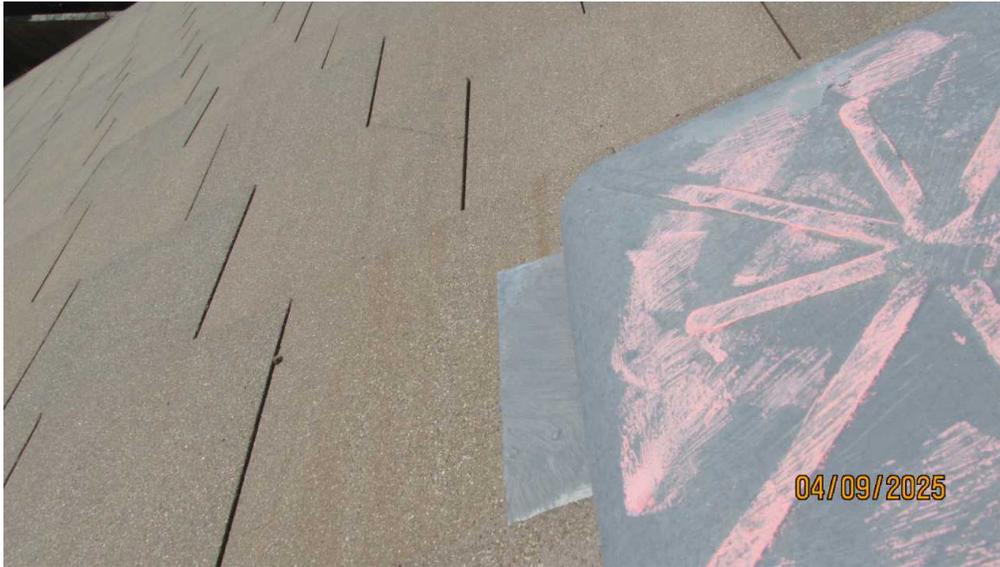
**29-Gilmore**

hail dents in soft metal vents

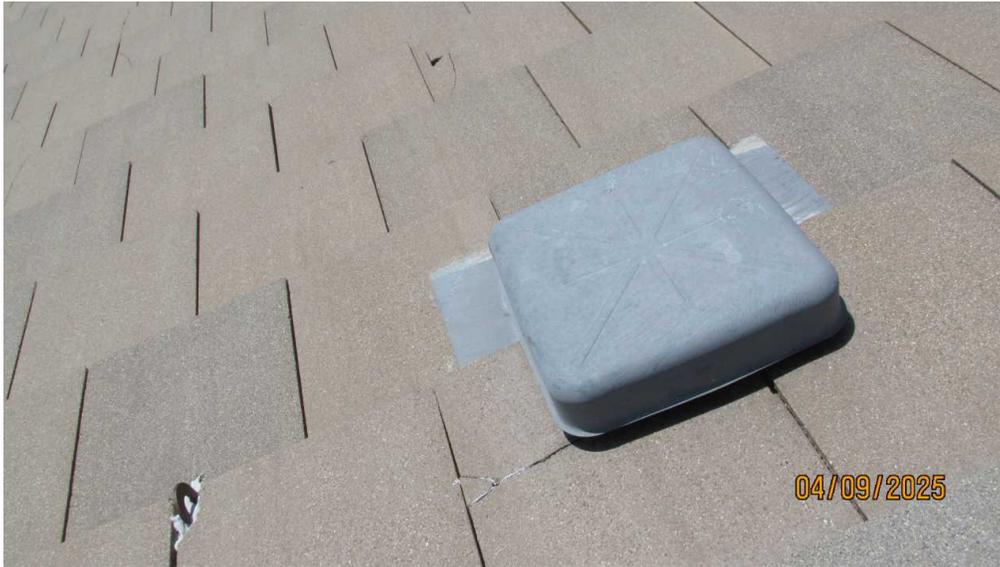
## 31-Gilmore

hail dents in soft metal vents

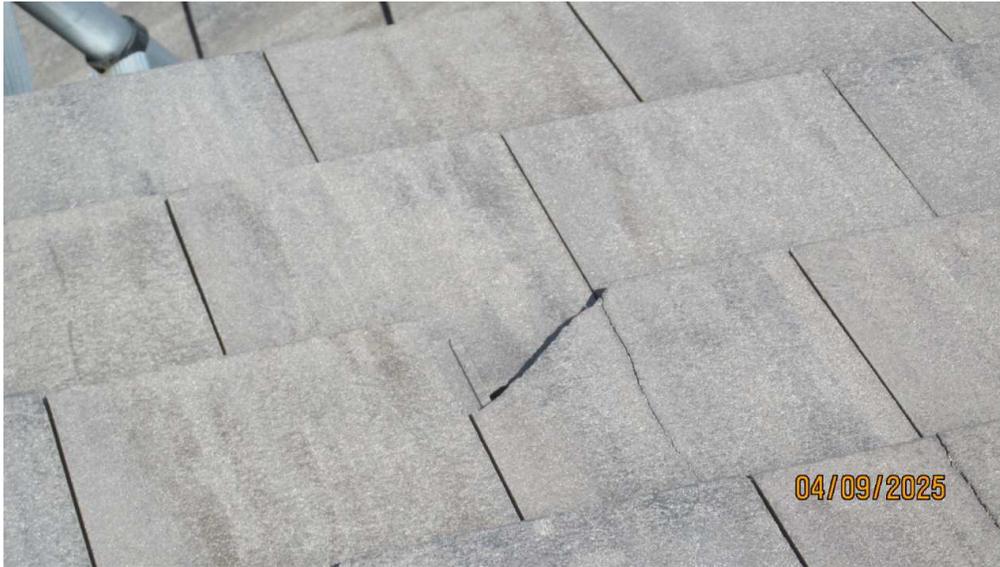
**41-Gilmore**

cracked/damaged tile

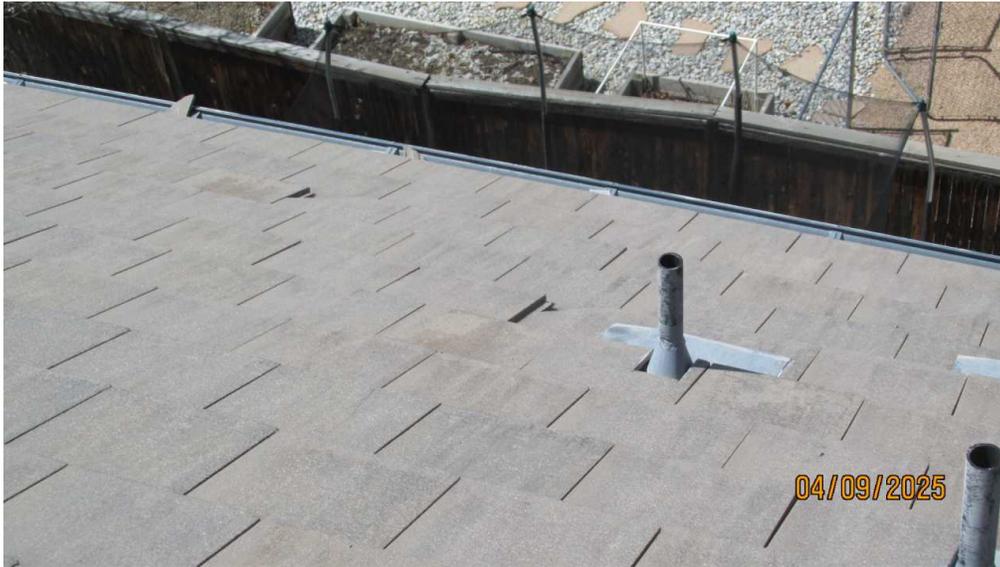
**43-Gilmore**

cracked/damaged tile

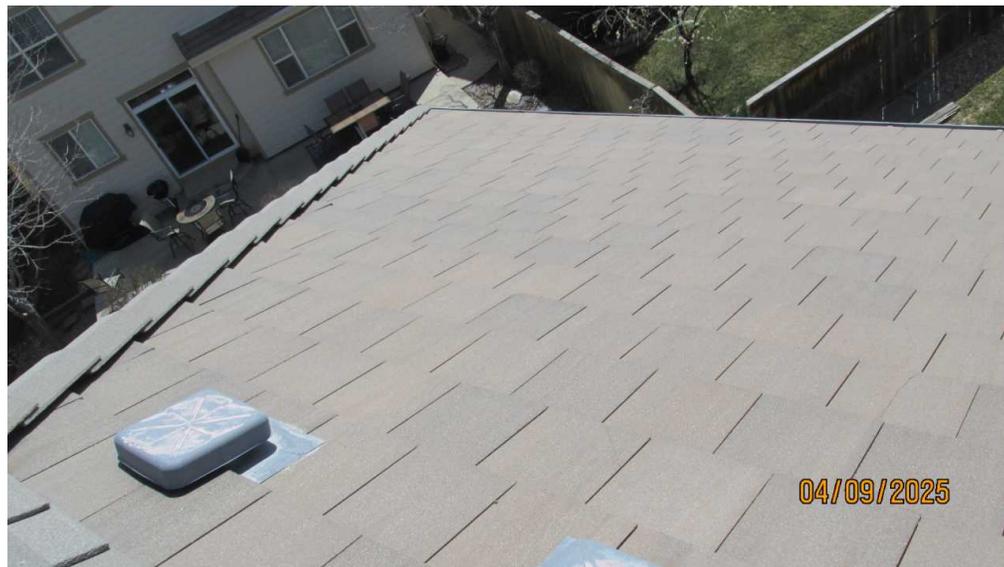
## 47-Gilmore

cracked/damaged tile

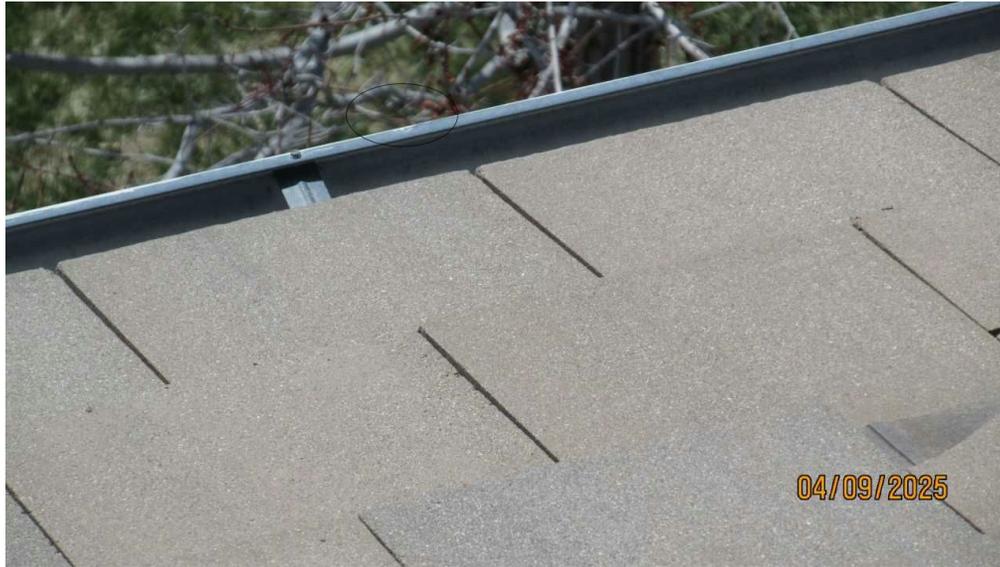
**51-Gilmore**

hail dent in gutter

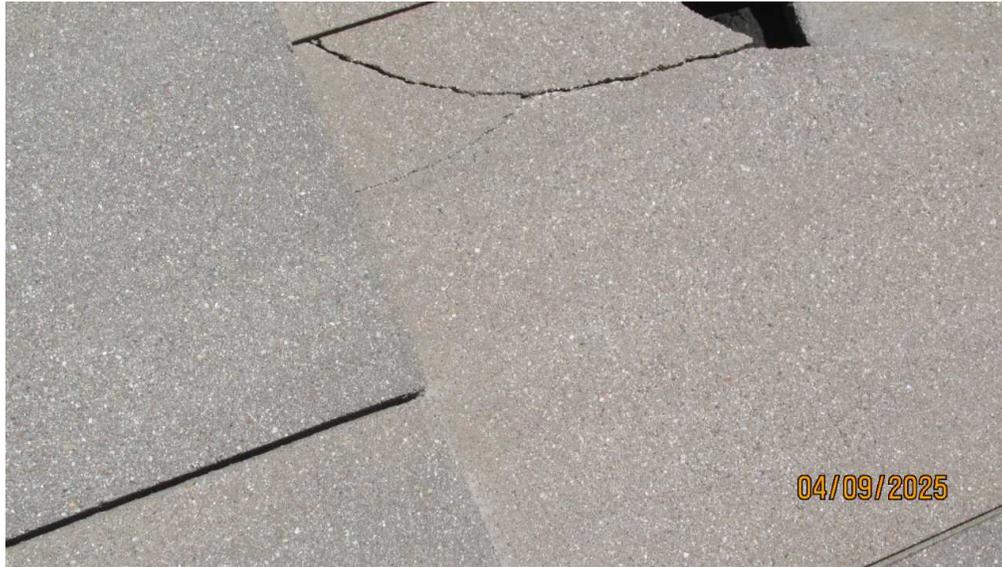
**53-Gilmore**

cracked/damaged tile

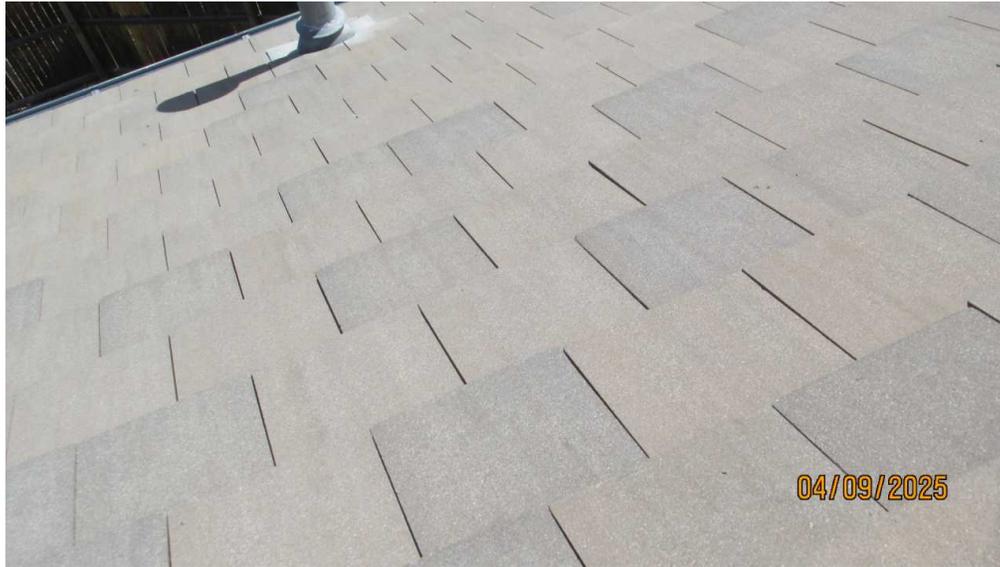
**57-Gilmore**

Most of right slope ok

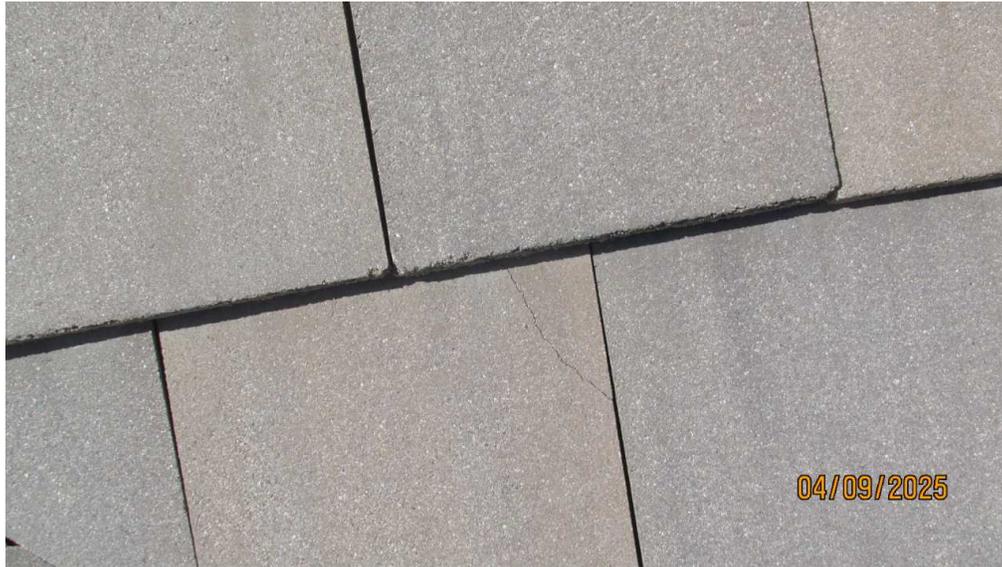
**59-Gilmore**

cracked/damaged tile

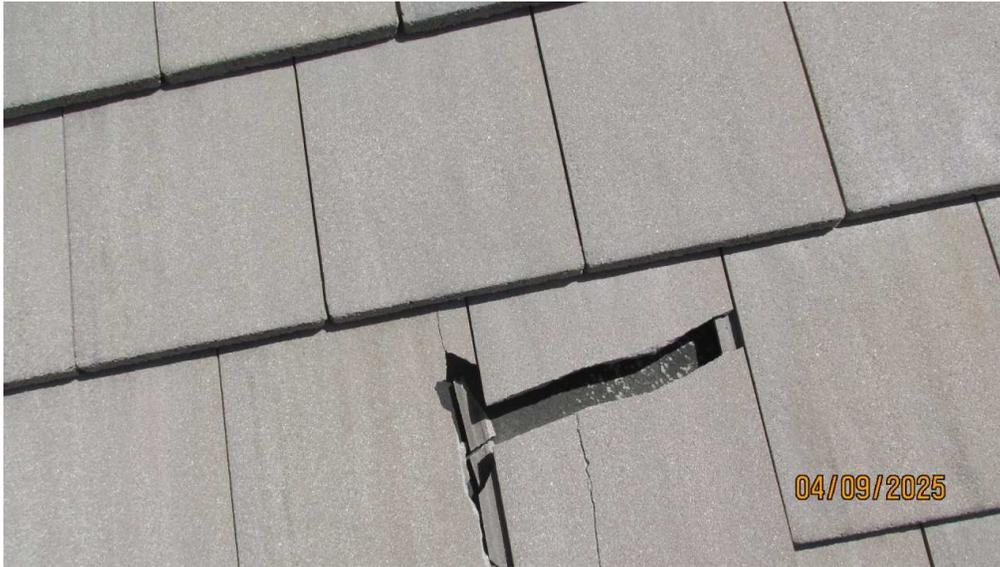
**63-Gilmore**

cracked/damaged tile

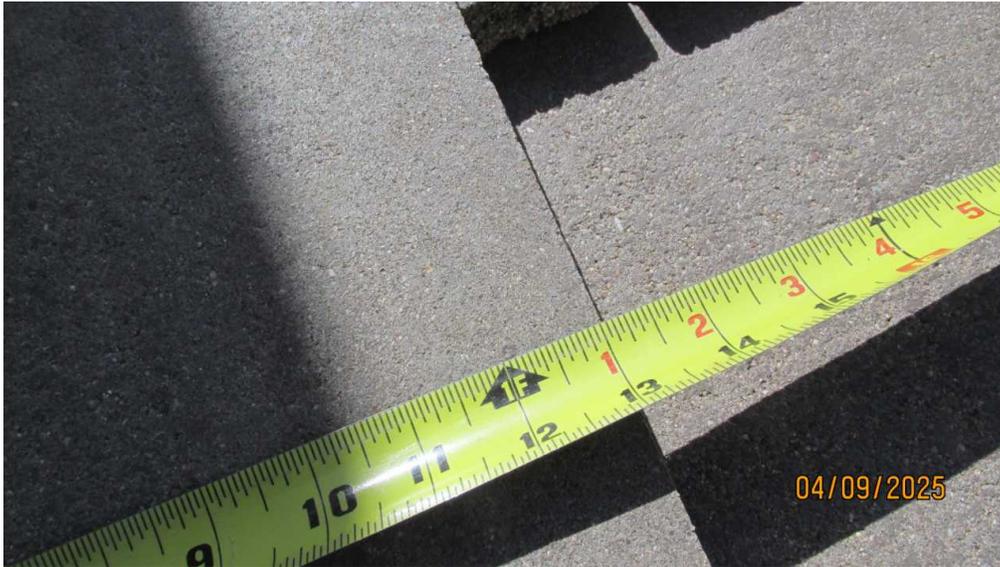
**67-Gilmore**

tie details

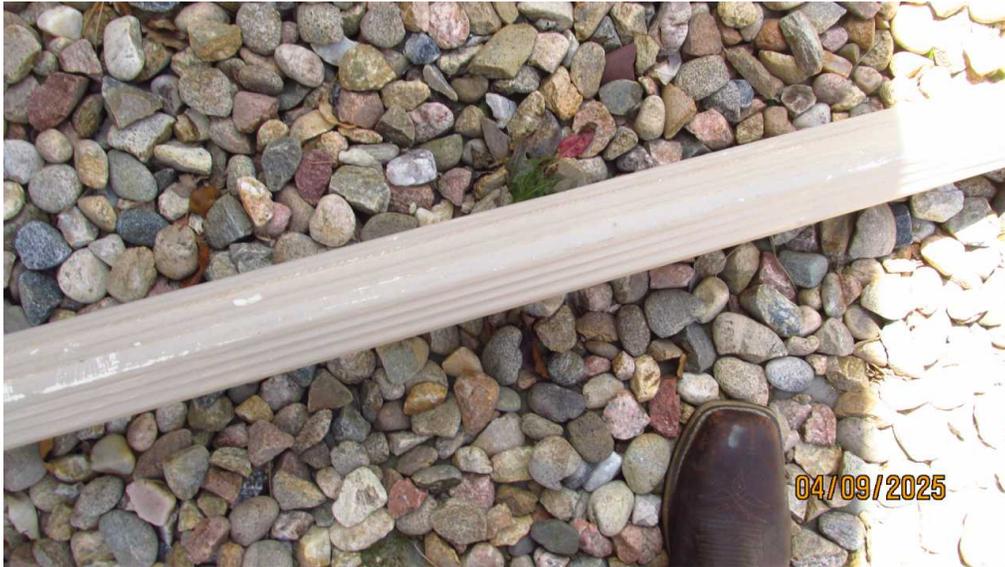
**91-Gilmore**

downspout ok

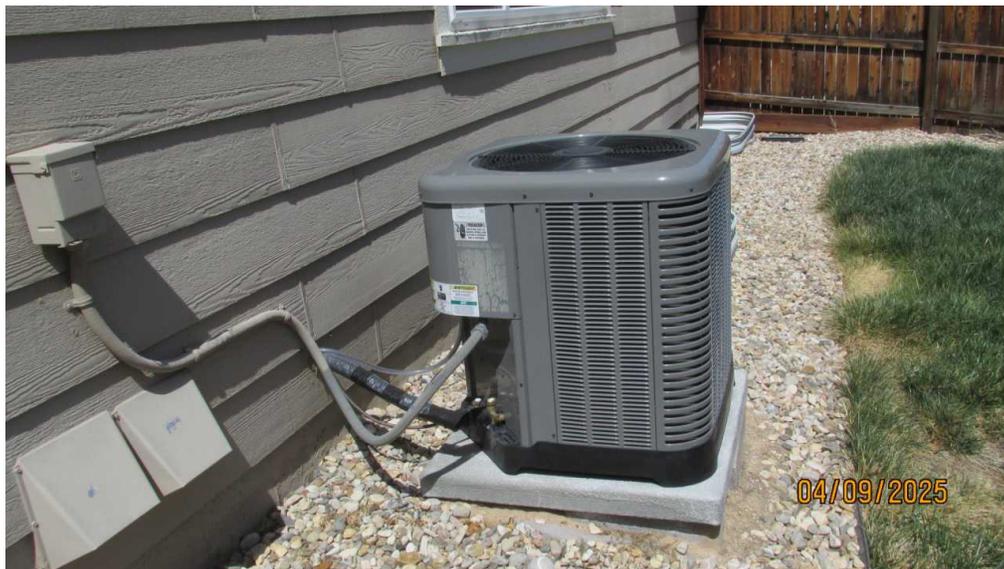
**103-Gilmore**

No storm damage noted
