# NIST Releases Technical Findings on What Caused the 2021 Partial Collapse of Champlain Towers South

June 22, 2026

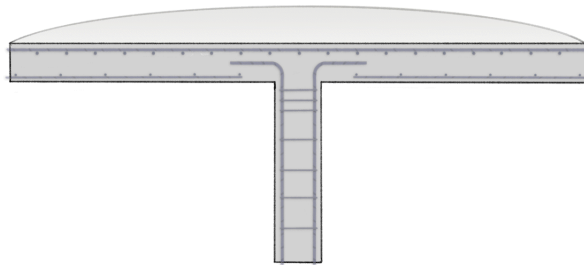
*This animation illustrates how forces pushing down on a steel-reinforced concrete slab can cause it to bend and crack around a supporting column, weakening the connection holding the slab in place until it ultimately fails. National Construction Safety Team experts determined that this type of “punching shear failure” at two columns in the garage under the pool deck slab in early June 2021 led to the June 24, 2021, partial collapse of the Champlain Towers South building.*

Today the National Institute of Standards and Technology’s National Construction Safety Team released its technical findings on the cause of the partial collapse of the Champlain Towers South building on June 24, 2021, which took the lives of 98 people. Following an extensive technical investigation, the team has concluded that the collapse began in early June 2021, when two connections between garage columns and the pool deck failed. These initial column failures caused cracks to grow and loads to redistribute in the pool deck over the next three weeks, resulting in the transfer of their loads to adjacent slab-column connections that were not strong enough to support them. This led to the larger catastrophic collapse on June 24.

“The low margins against failure were primarily caused by two factors,” explained Bell. “First, severe and widespread deviations in the building’s original structural design from the codes and standards of the day, but also some limitations in those codes and standards. And second, deviations in the building’s construction from the design drawings.”

Loads added to the structure over its lifetime — including pool deck modifications described in a [previous investigation update](https://www.nist.gov/news-events/news/2025/06/nist-releases-extensive-video-update-champlain-towers-south-investigation) — further diminished the margins against failure, as did long-term degradation from corrosion.
