# Exhibit A

Allen Consulting Services  
Building Consulting and Appraisal Services

5/8/2025

Co. Claim Number : 300-438846-2023  
Insured : Gina Gilmore  
Policy Number : 44-883661-00  
Policy Term : 1/28/2023 to 1/28/2024  
Date of Loss : 5/10/2023  
Location of Loss : 9285 Melborne Ct  
Parker, CO 80134

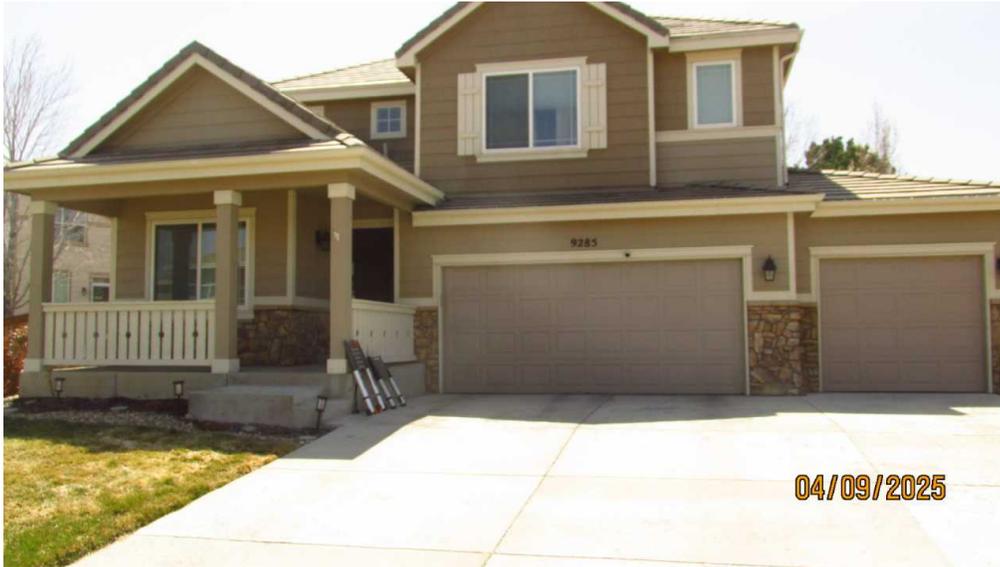
**1-Gilmore**

Front Elevation

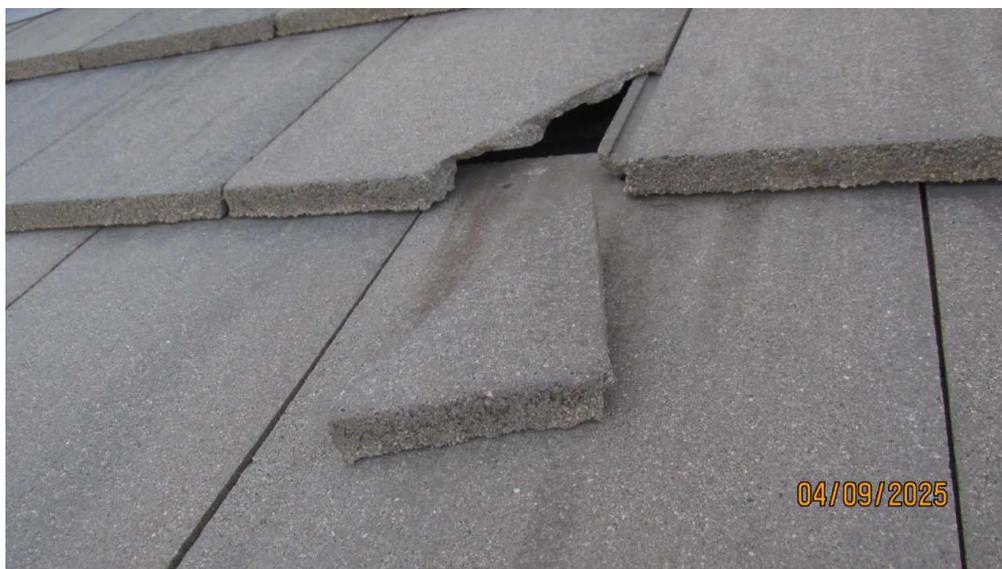
## 6-Gilmore

cracked/damaged tile

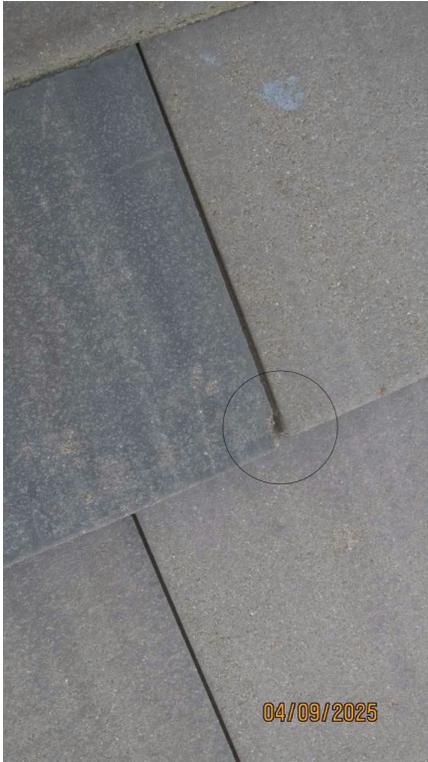
## 9-Gilmore

chipped tile

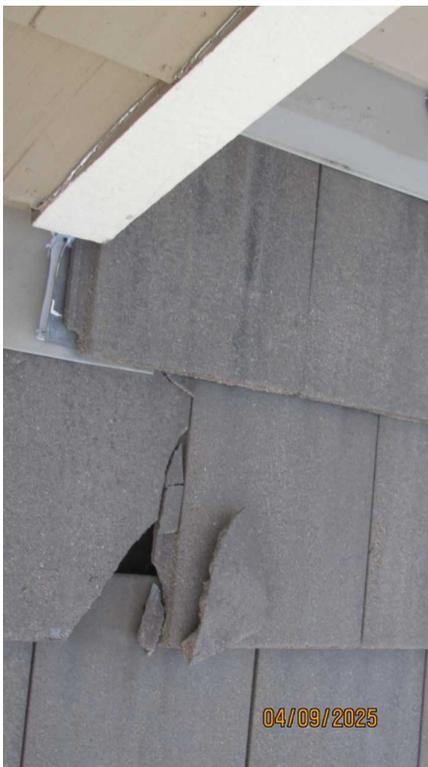
## 10-Gilmore

cracked/damaged tile

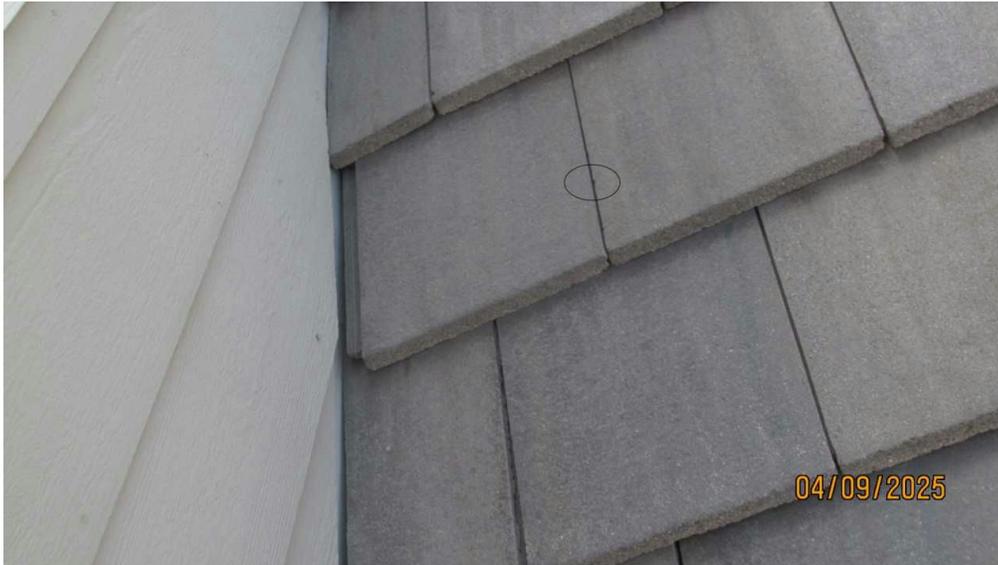
**11-Gilmore**

chipped tile

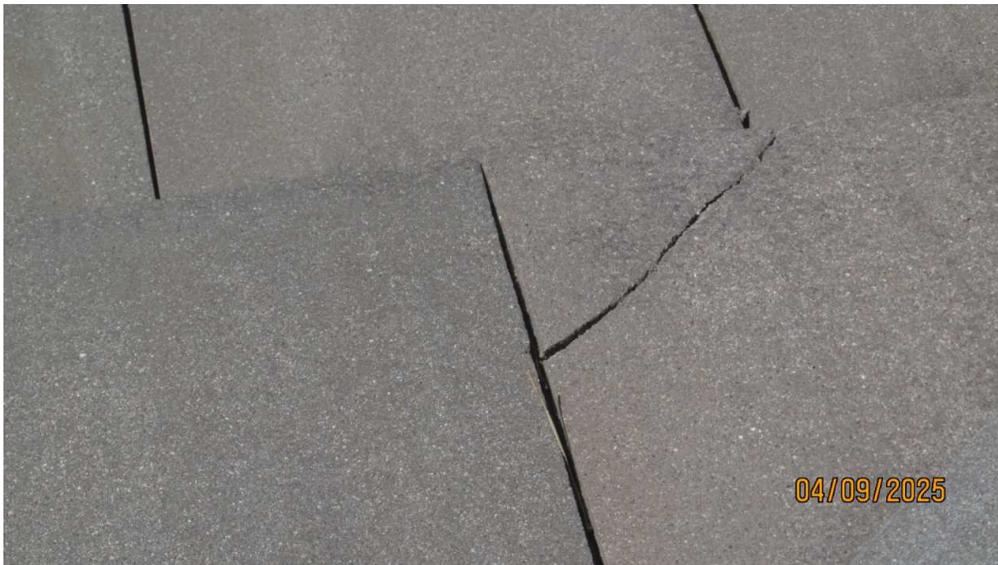
**12-Gilmore**

cracked/damaged tile

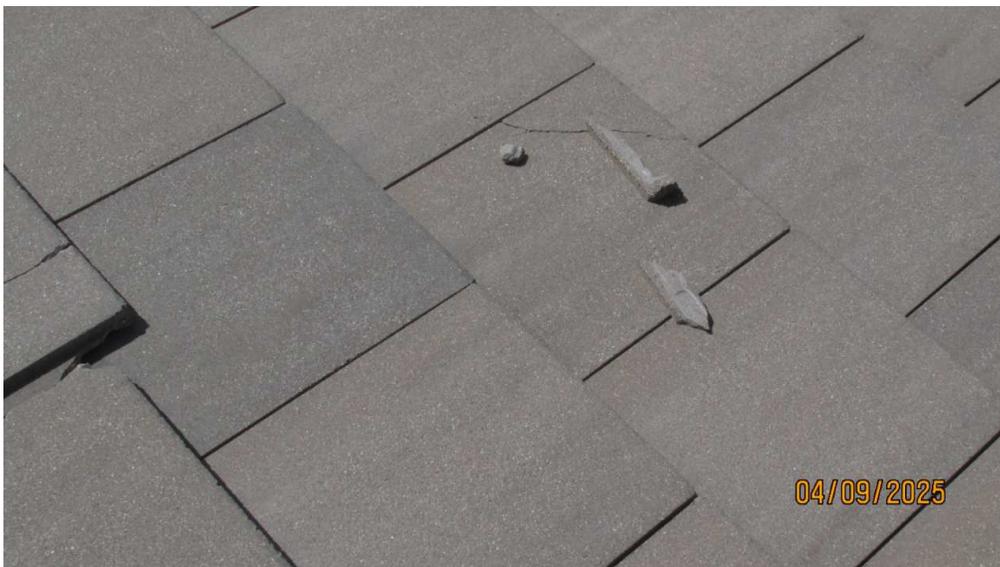
**14-Gilmore**

cracked/damaged tile

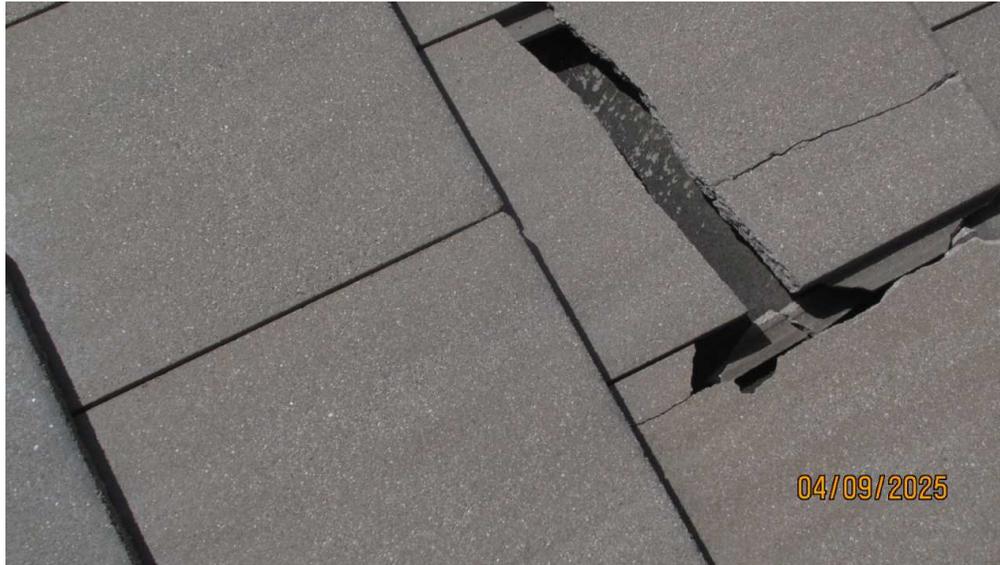
**15-Gilmore**

cracked/damaged tile

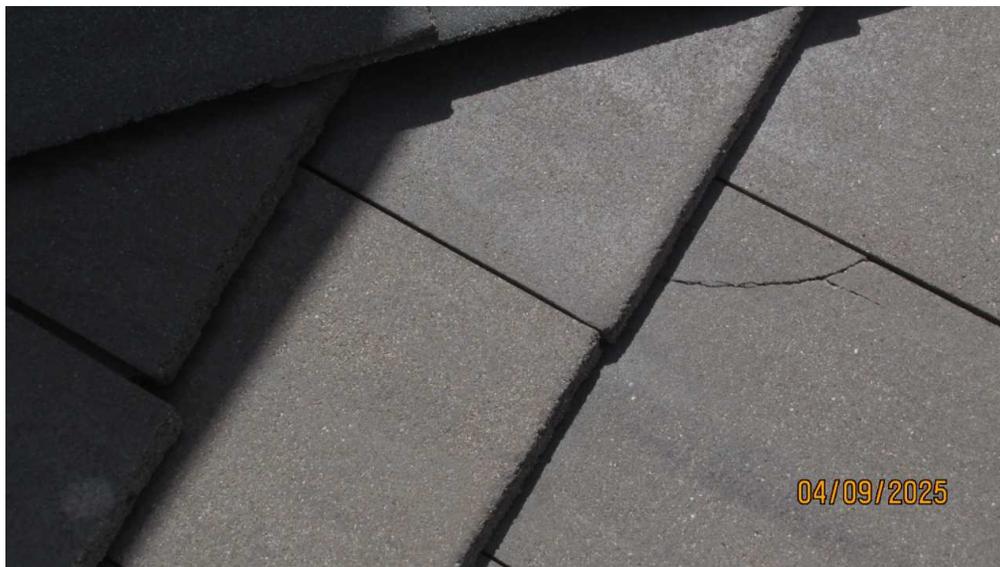
**16-Gilmore**

cracked/damaged tile

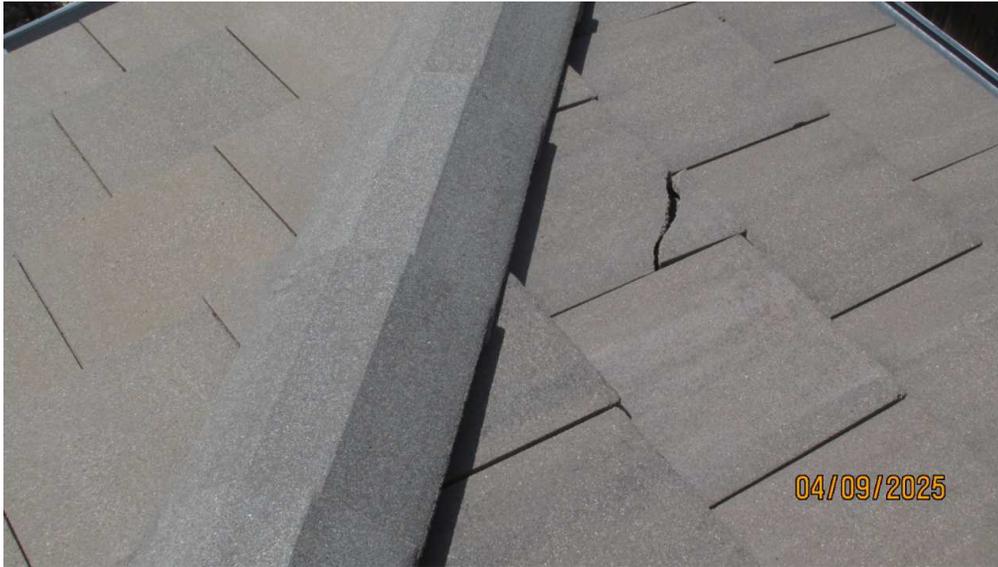
**17-Gilmore**

cracked/damaged tile

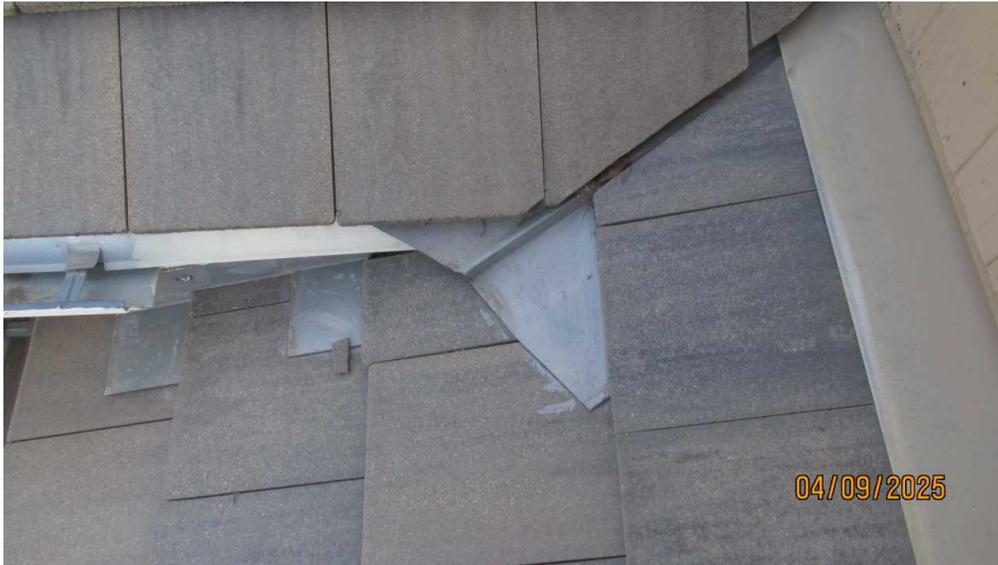
**19-Gilmore**

Valley metal

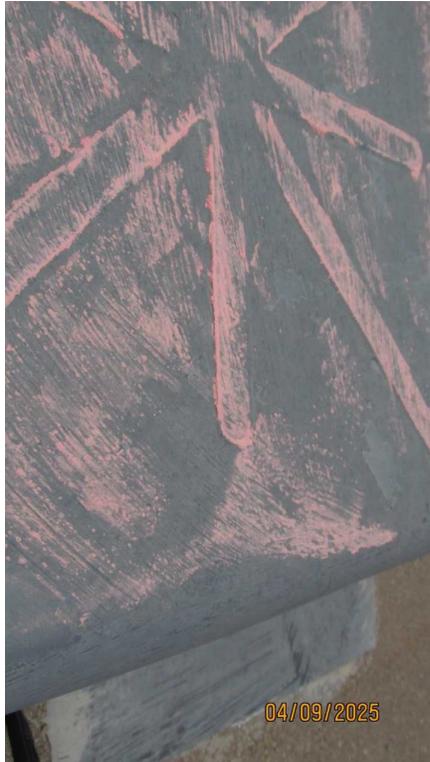
## 27-Gilmore

hail dents in soft metal vents

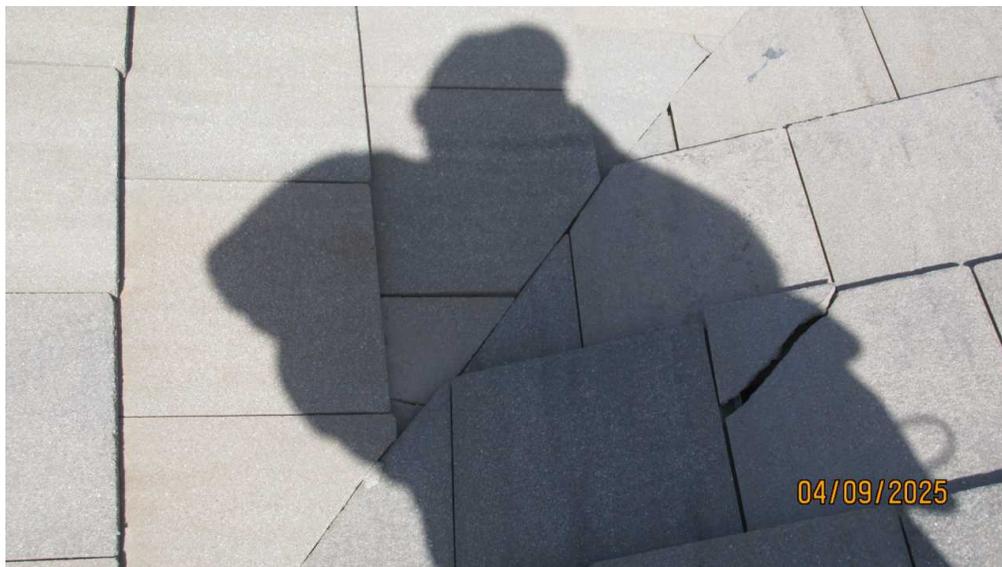
**34-Gilmore**

cracked/damaged tile

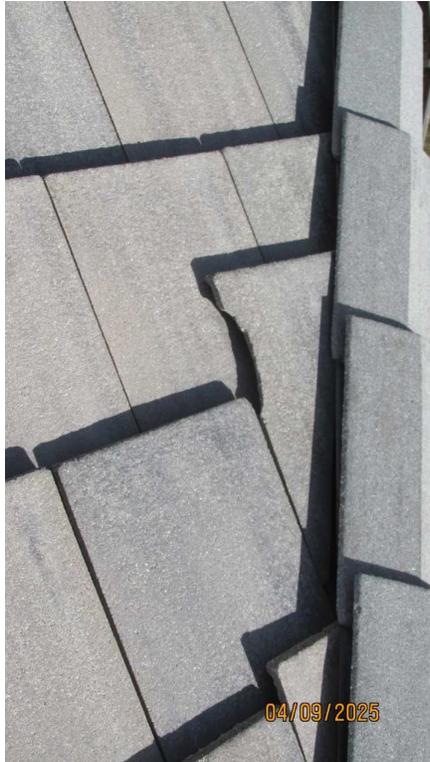
## 35-Gilmore

cracked/damaged tile

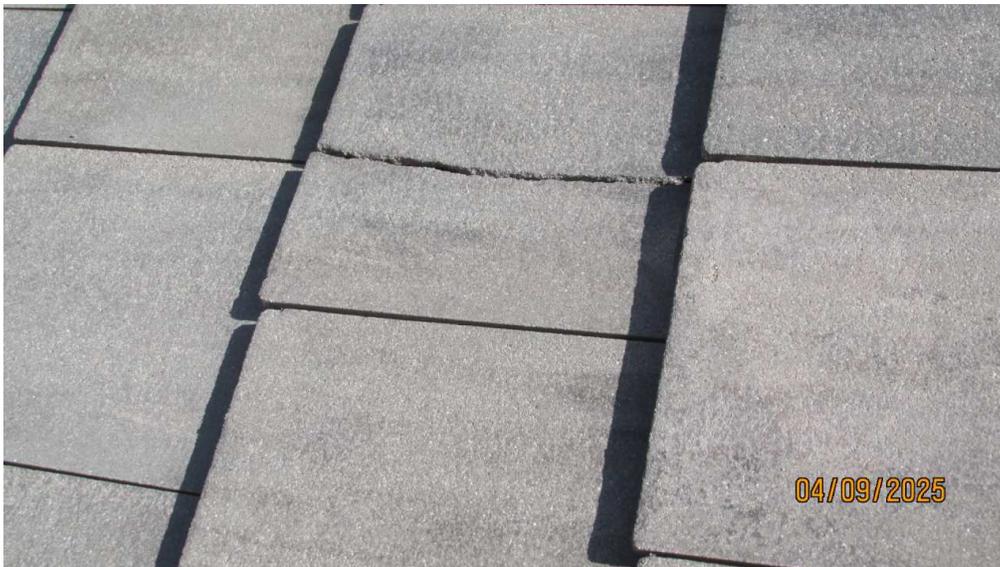
## 36-Gilmore

cracked/damaged tile

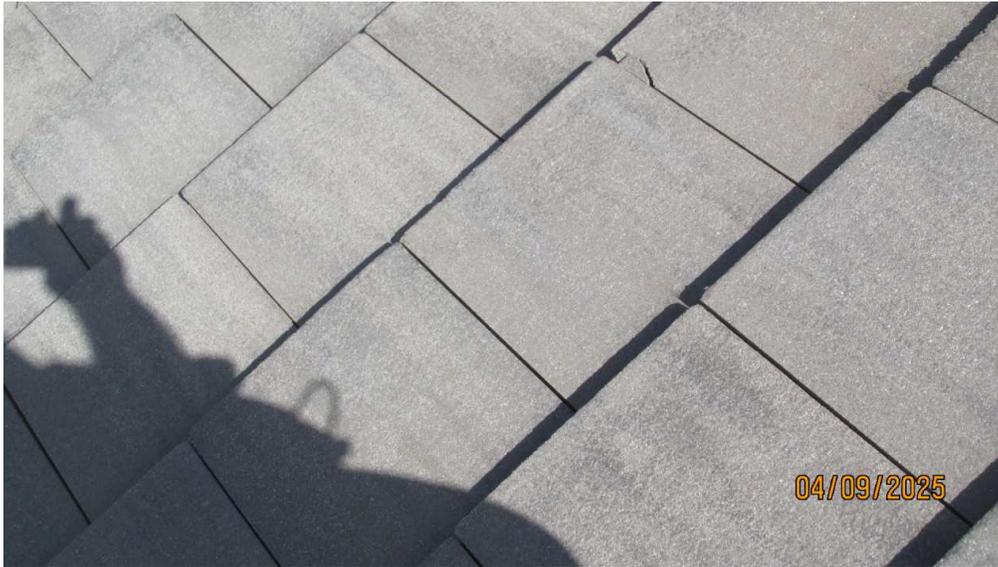
**37-Gilmore**

cracked/damaged tile

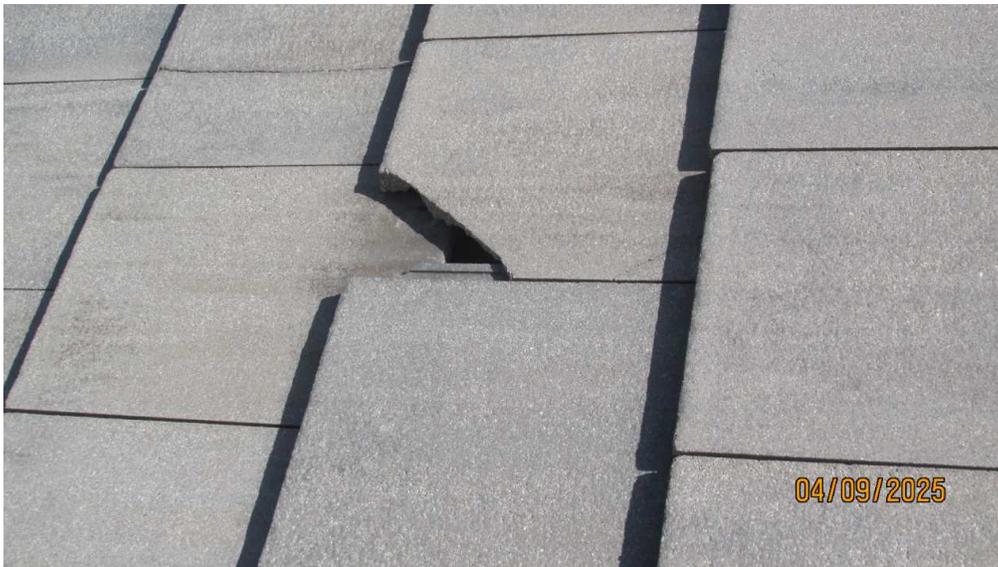
**38-Gilmore**

cracked/damaged tile

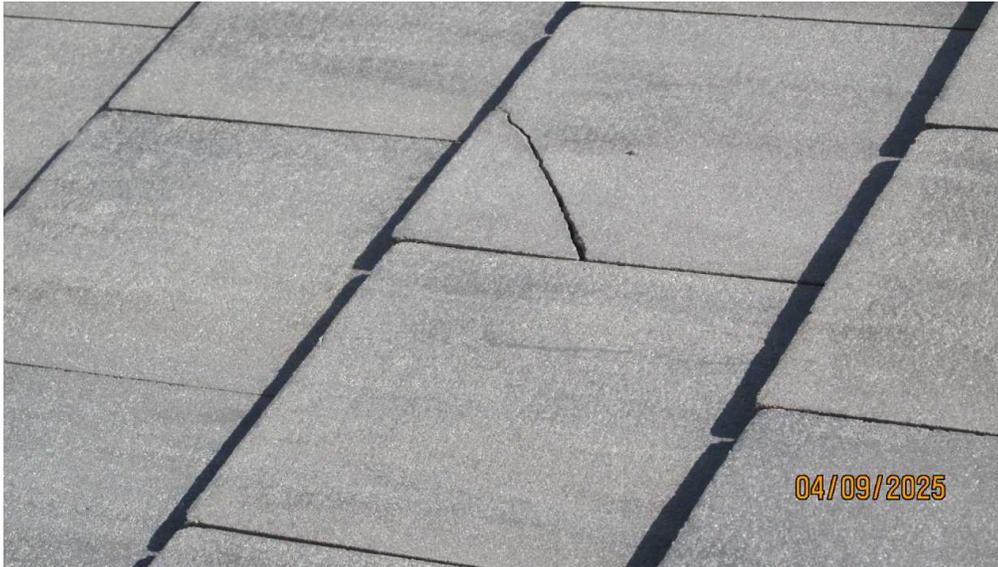
## 39-Gilmore

cracked/damaged tile

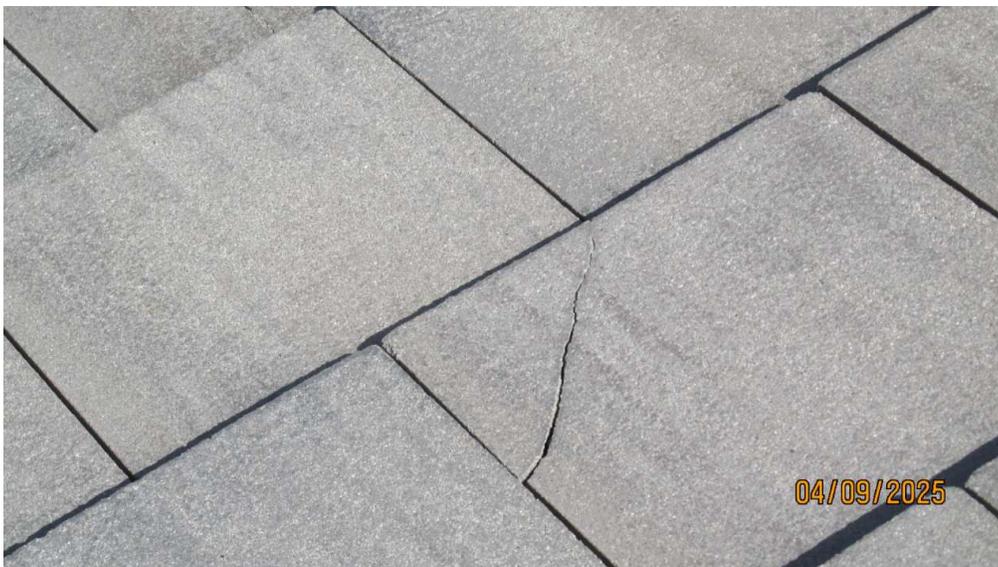
## 40-Gilmore

cracked/damaged tile

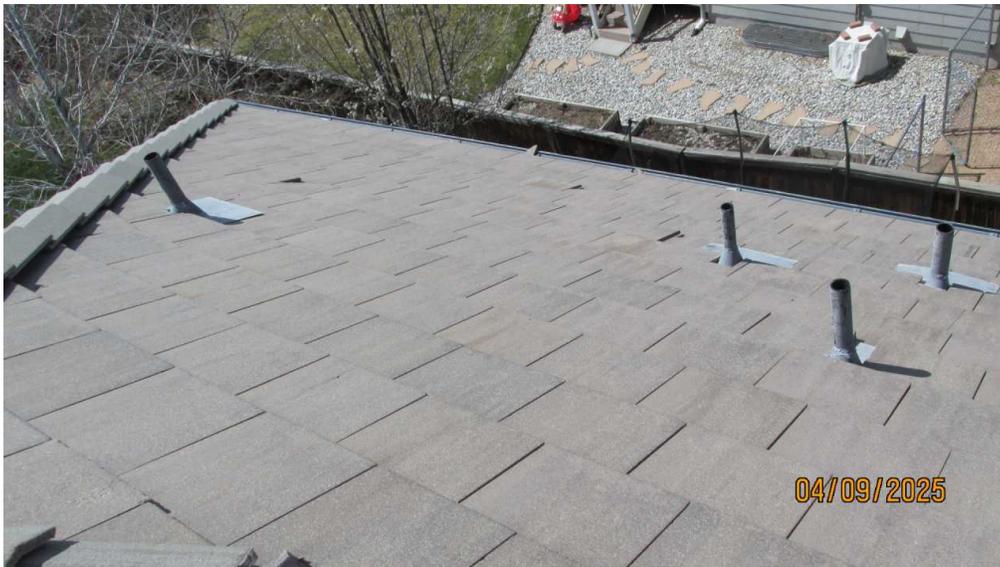
**42-Gilmore**

cracked/damaged tile

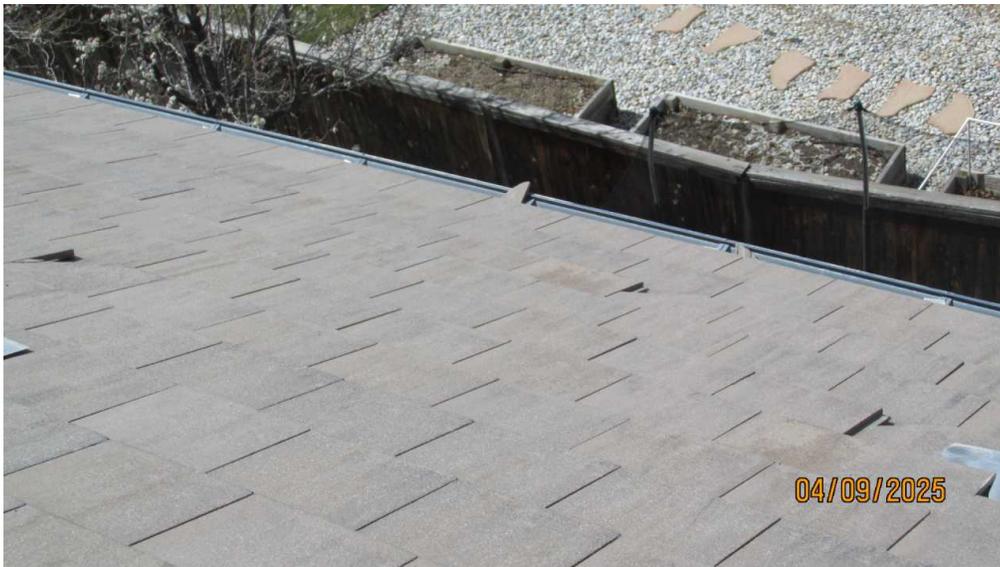
**44-Gilmore**

cracked/damaged tile

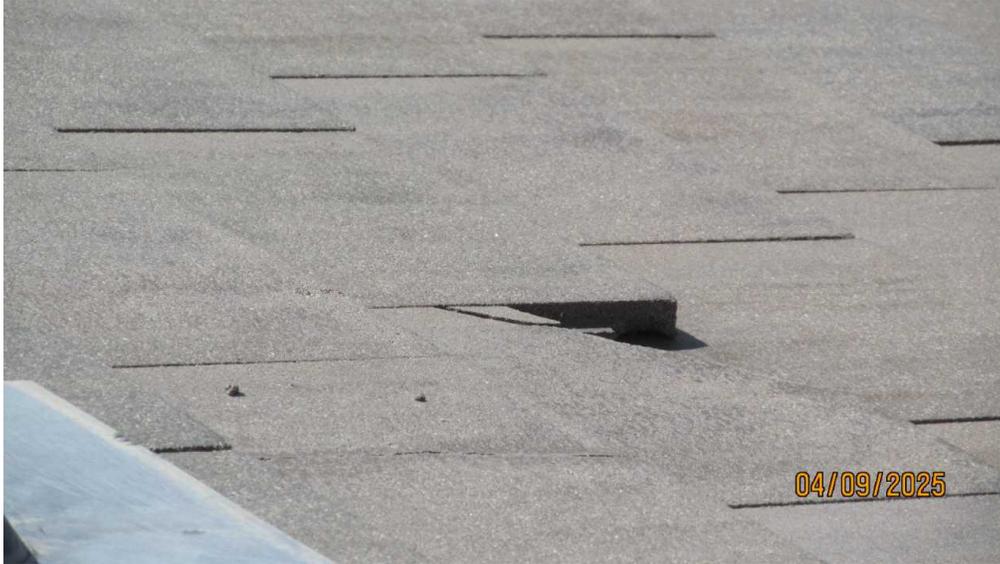
**45-Gilmore**

cracked/damaged tile

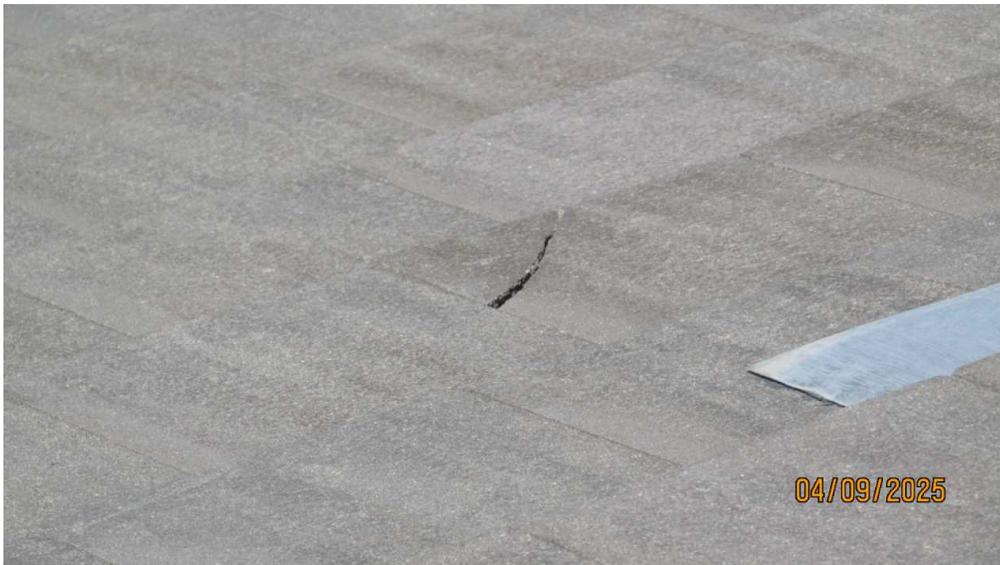
**46-Gilmore**

cracked/damaged tile

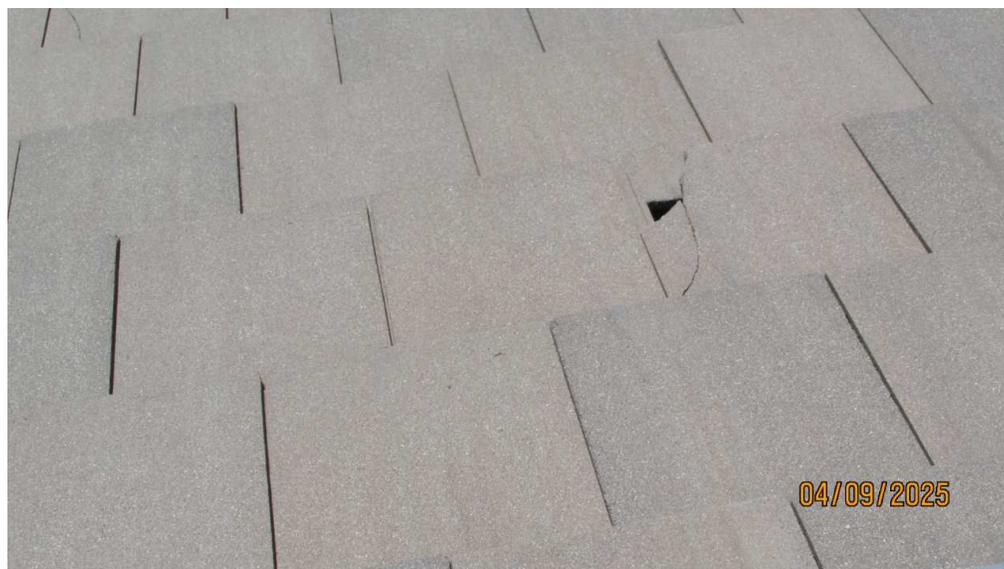
## 48-Gilmore

cracked/damaged tile

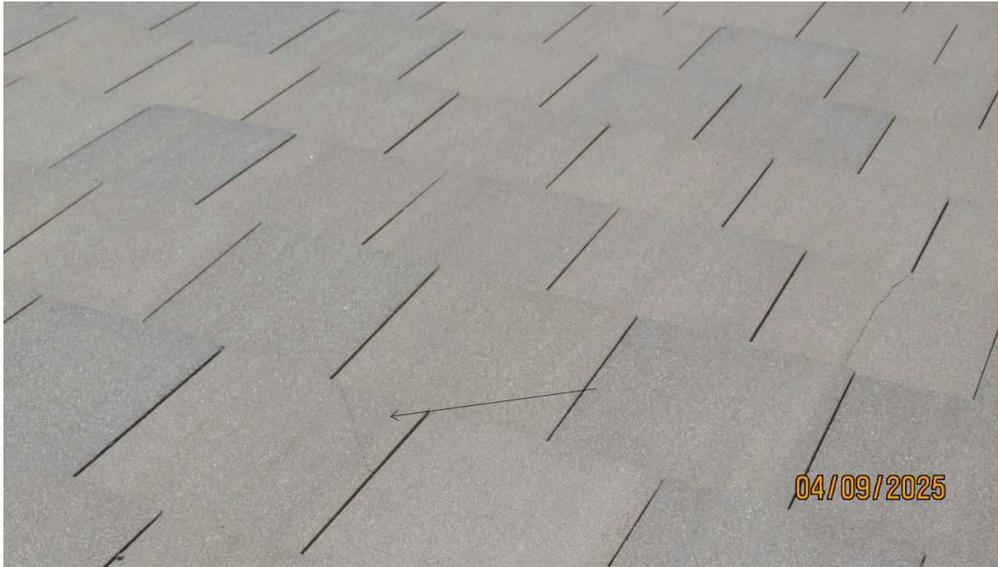
## 49-Gilmore

cracked/damaged tile

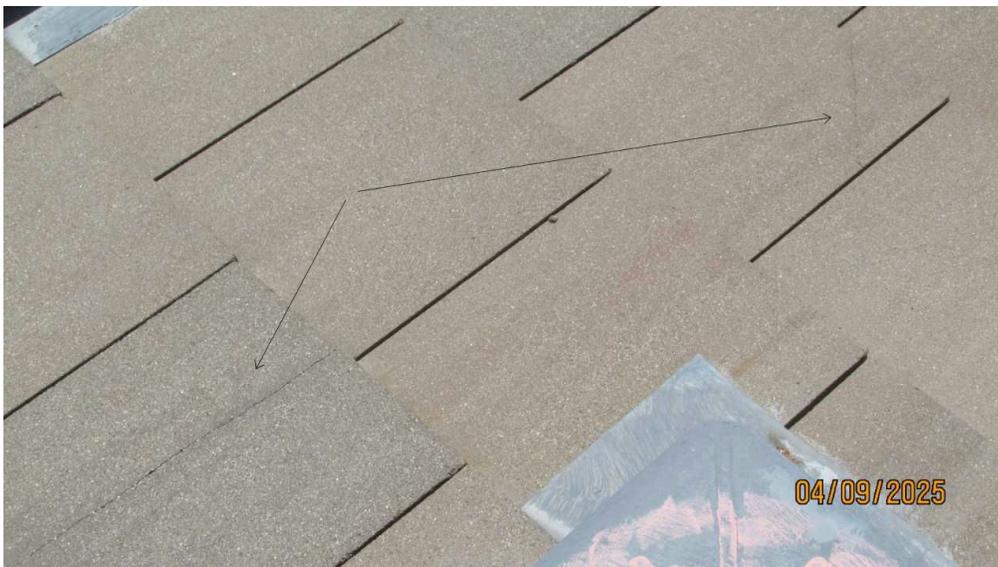
## 50-Gilmore

cracked/damaged tile

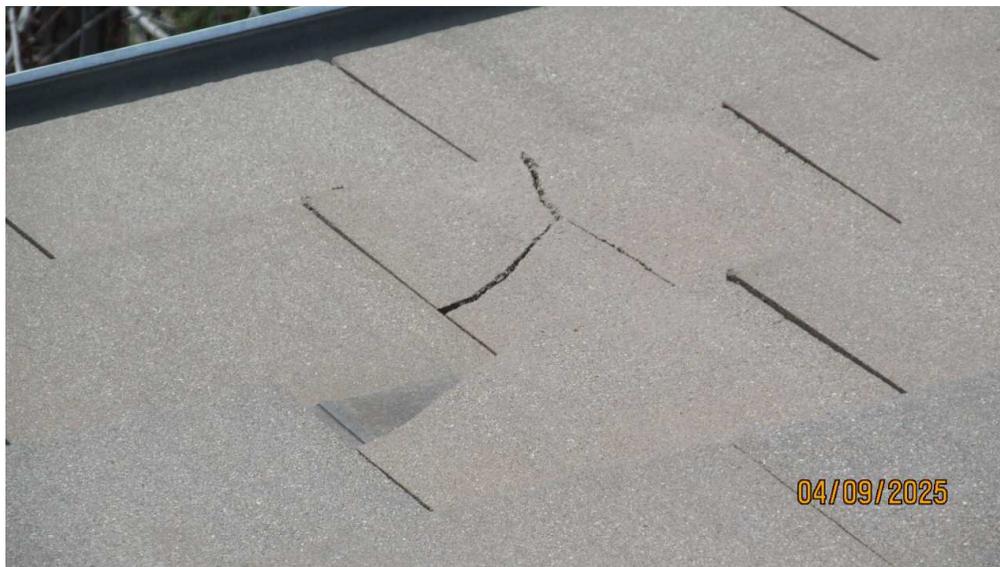
**52-Gilmore**

cracked/damaged tile

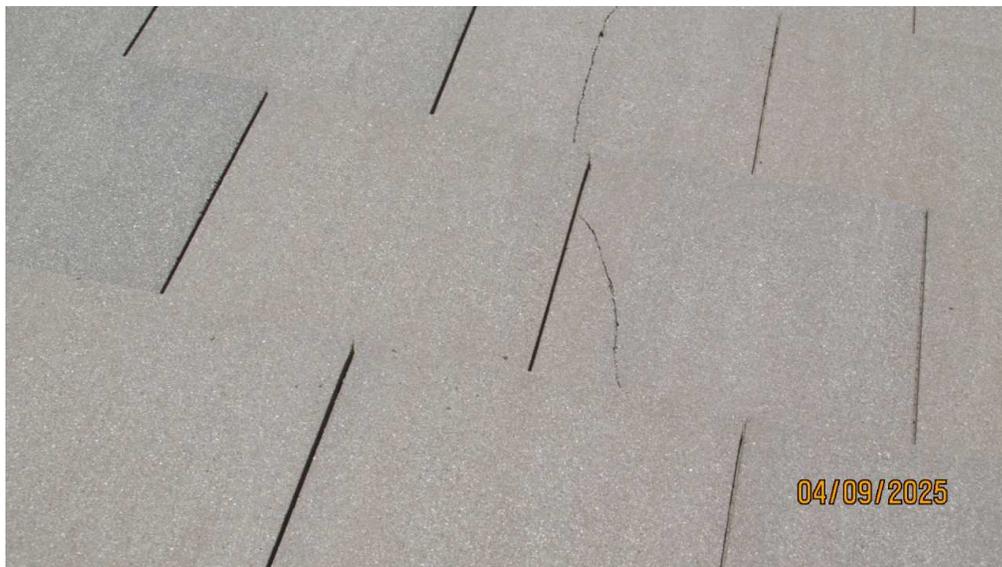
**54-Gilmore**

cracked/damaged tile

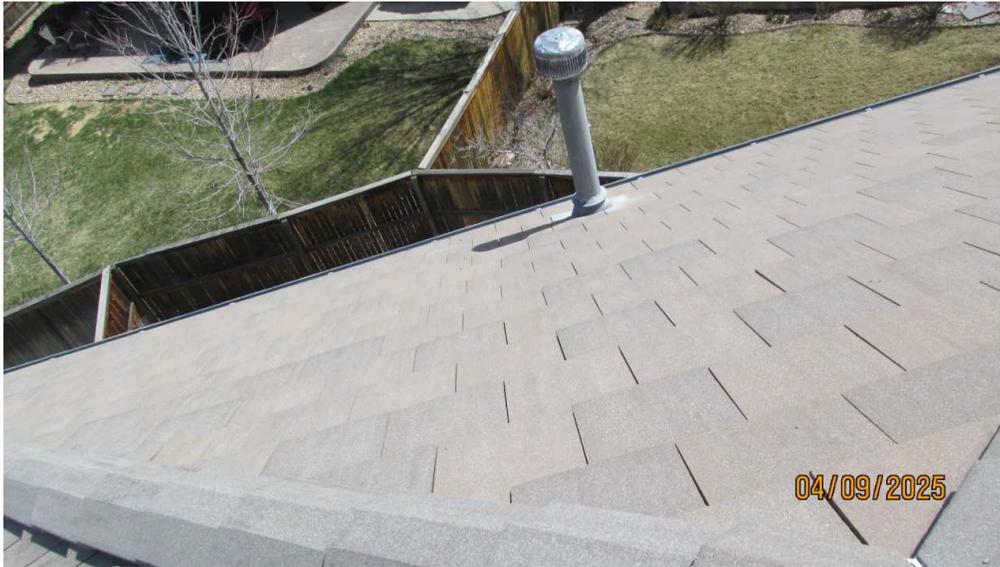
**55-Gilmore**

Right Slope

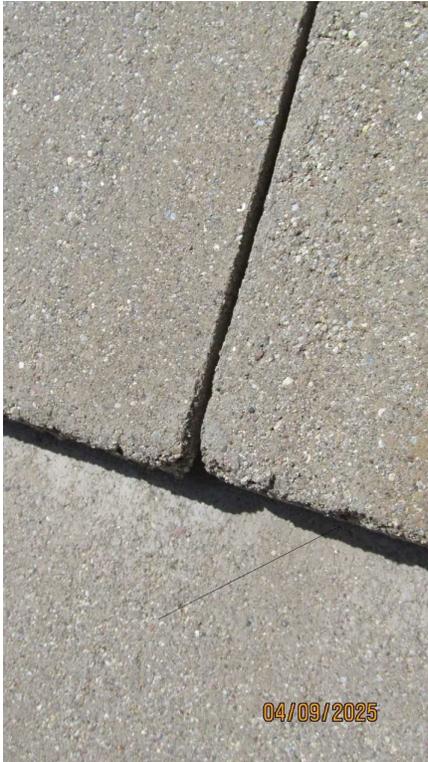
## 61-Gilmore

chipped tile

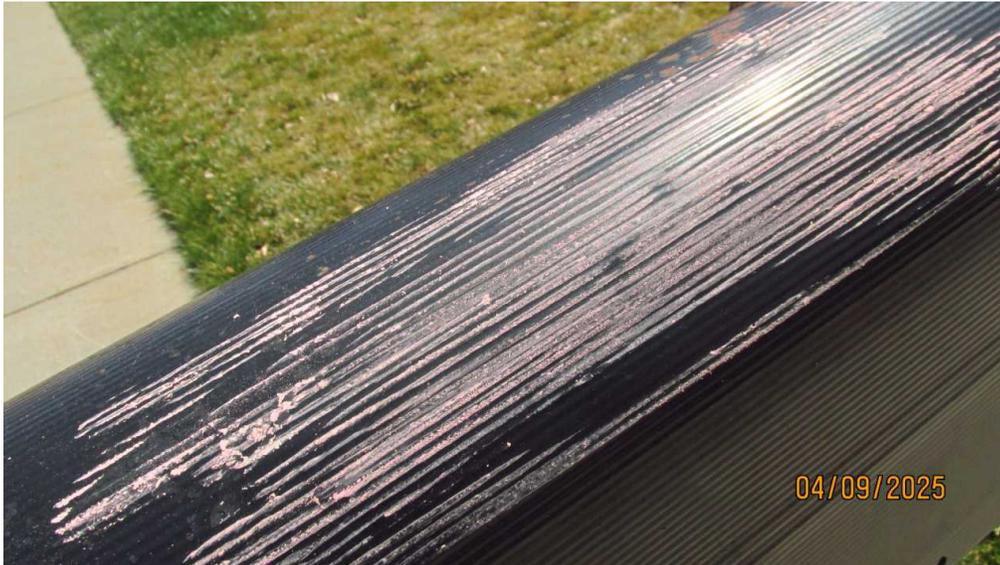
**77-Gilmore**

hail damage to mail box

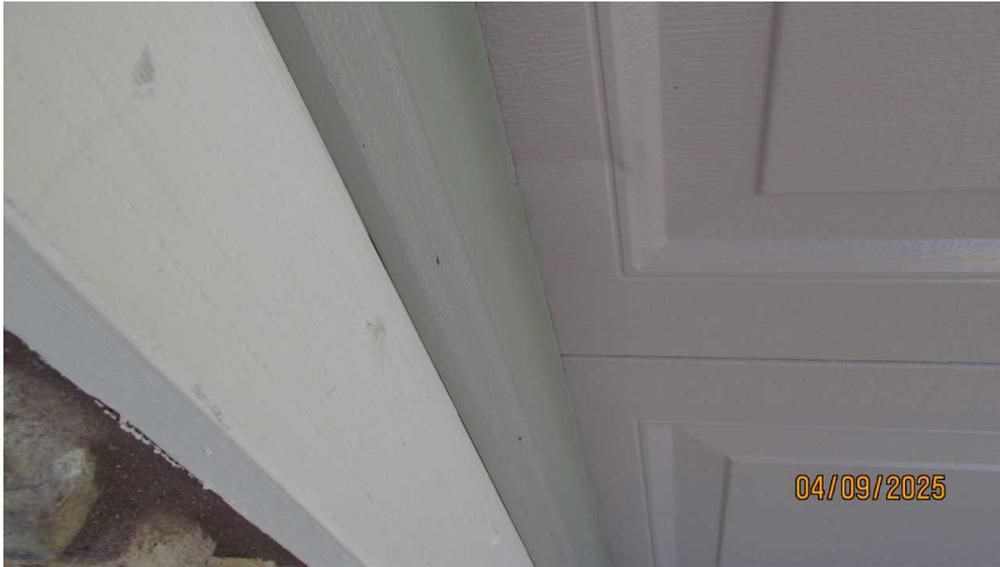
**79-Gilmore**

Mechanical damage to small door

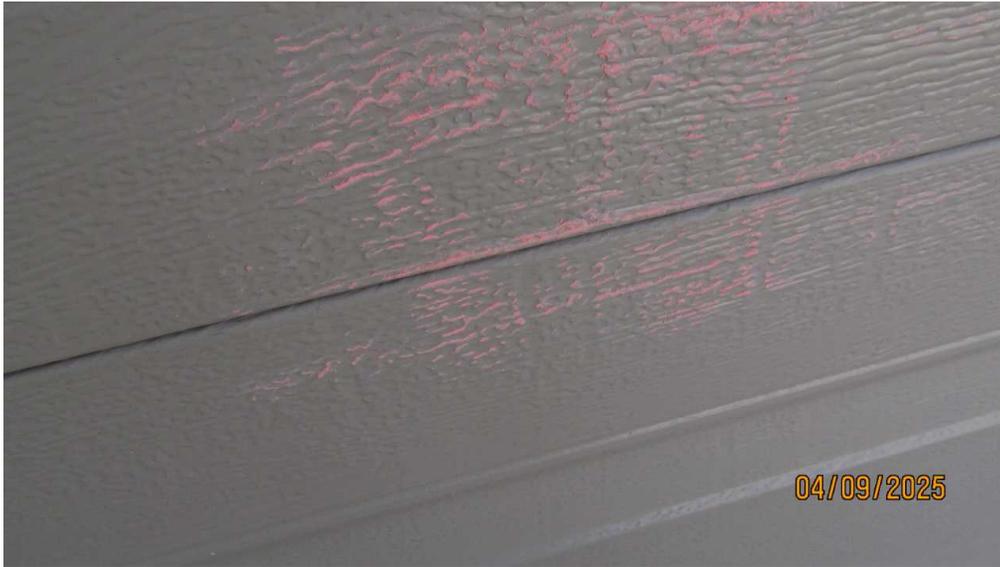
**81-Gilmore**

Hail dent in front large garage door

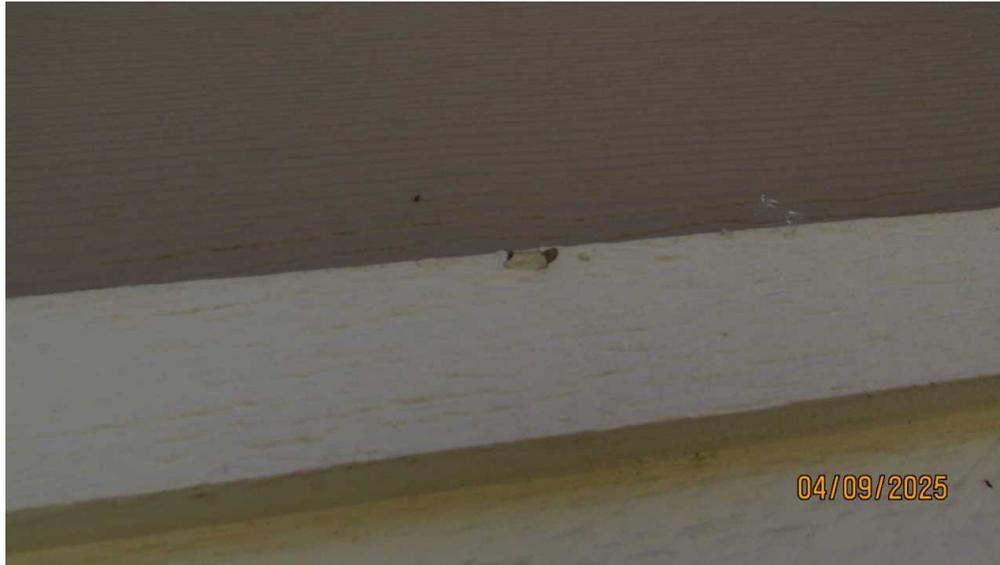
**83-Gilmore**

hail chips in trim around garage doors

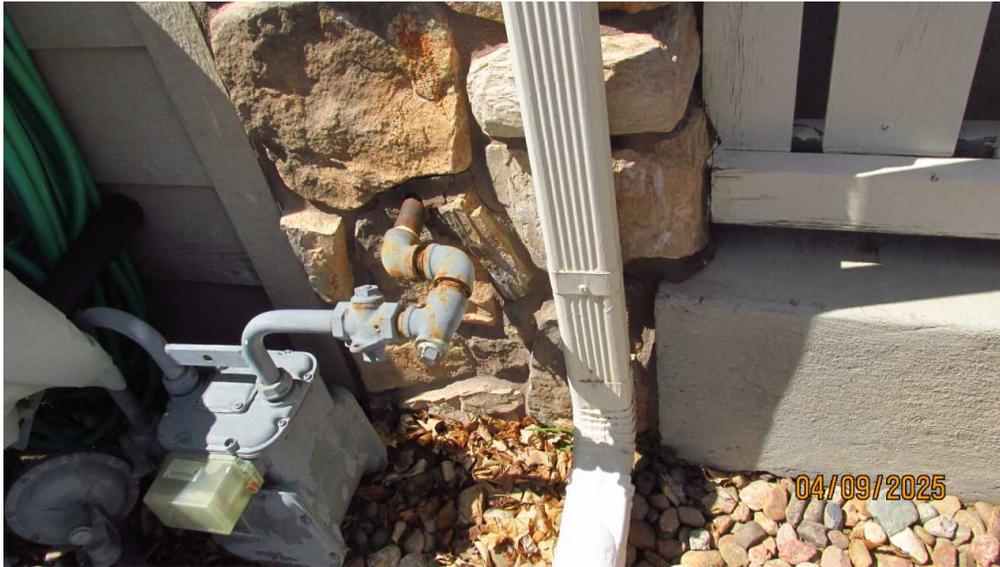
**85-Gilmore**

hail damage to downspout

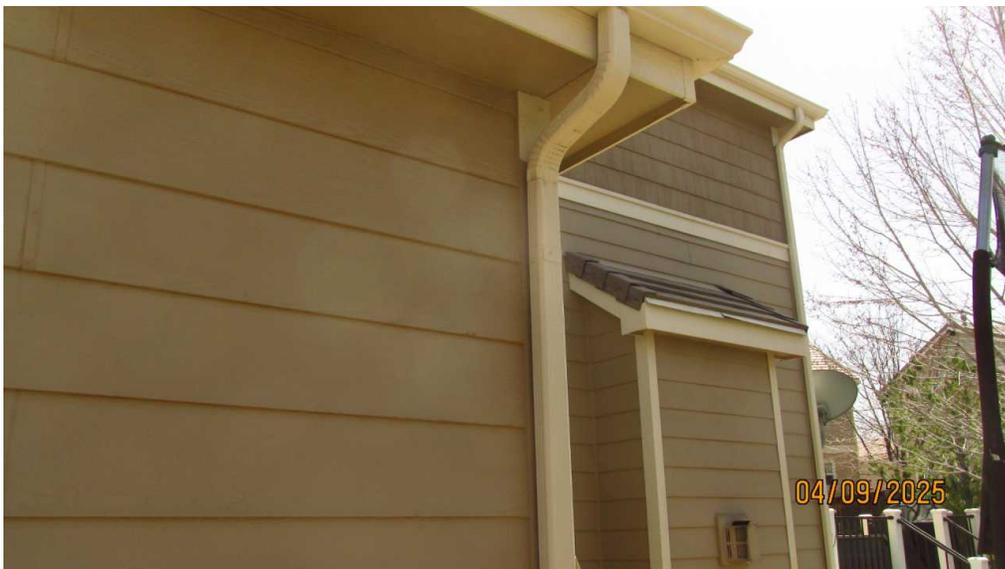
**92-Gilmore**

downspout ok

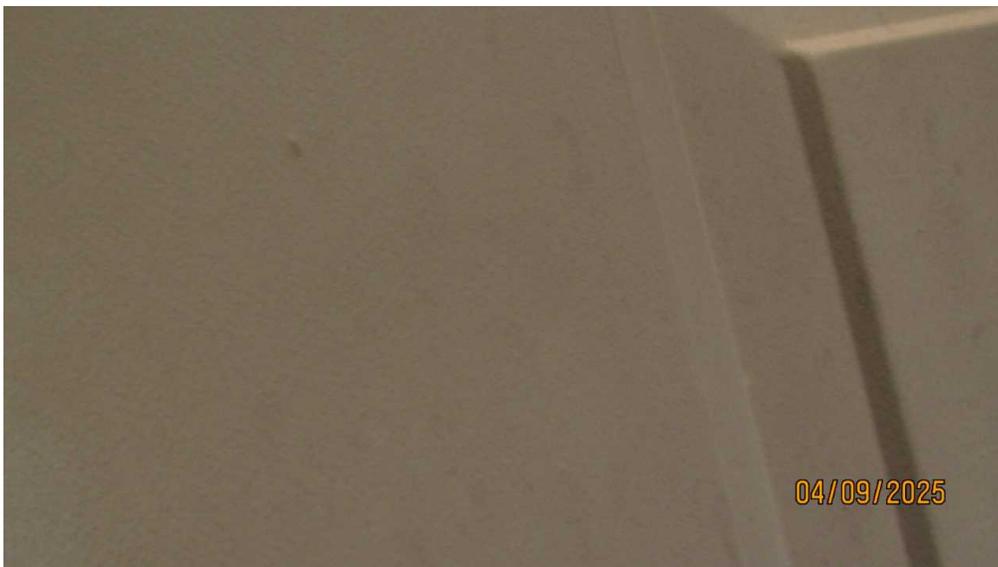
**96-Gilmore**

hail spatter on door

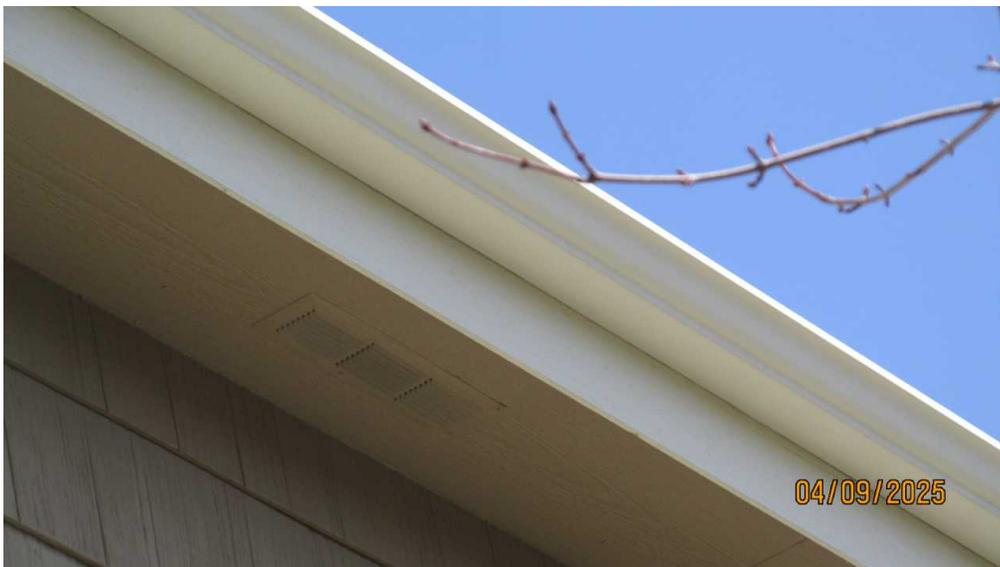
**100-Gilmore**

hail damage to trim paint

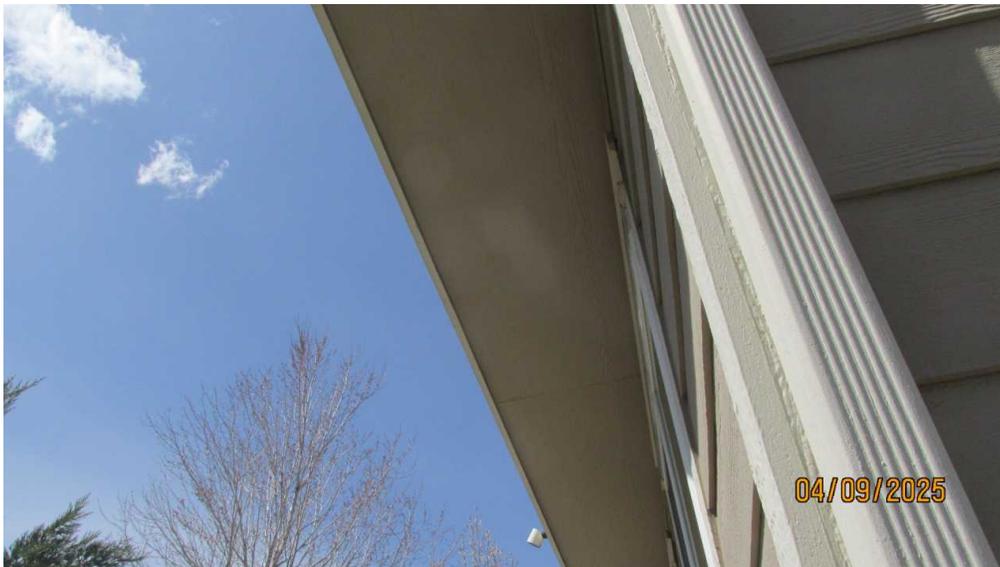
**102-Gilmore**

Left Elevation

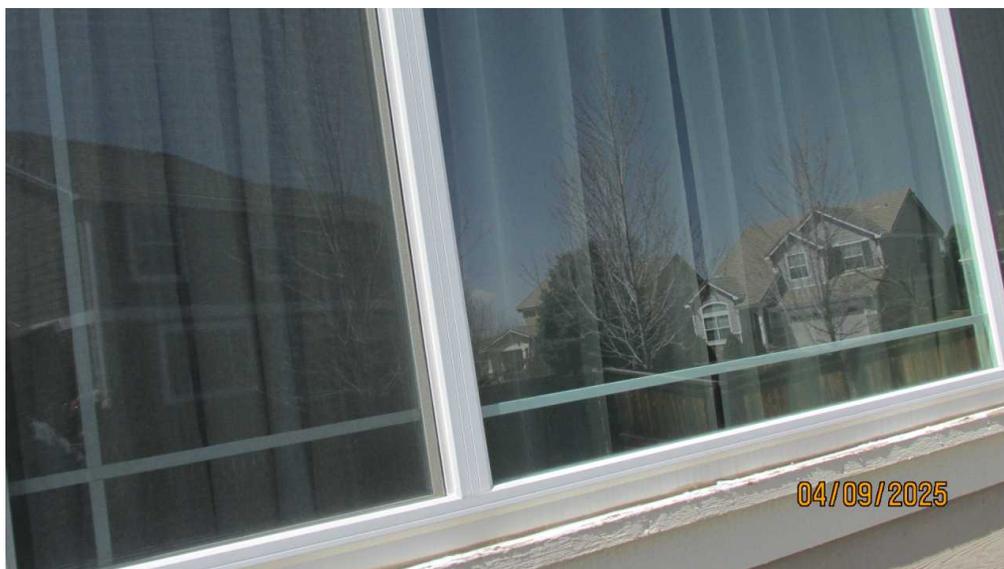
**104-Gilmore**

No storm damage noted

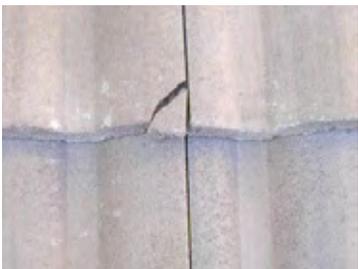
**Figure 1.** Broken cover lock corner
